**Flood Control Project Maintenance
Levee Inspections****LMA District Cover Sheet
Spring 2014 Levee Inspection Results****Reclamation District No. 0010 Honcut**

Spring 2014 Levee Inspection Results

Reclamation District No. 0010 Honcut

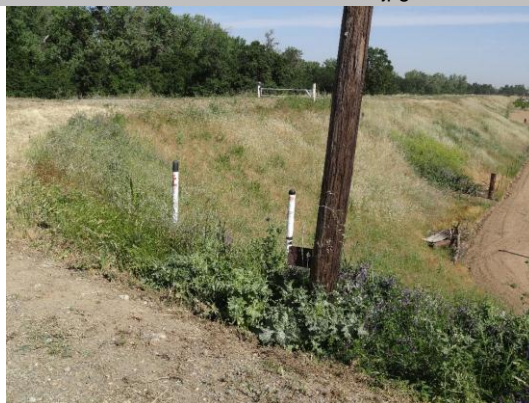
Photo 1 of 1 : UCIP_5470.jpg

LM Start	0.00	Rating **	M	Issue No.	3
LM End	0.00	Issue Type +	En	Location *	CR
Category	Supplemental			GPS Latitude/Longitude	
				Start	End
Item	DWR UCIP Field Study			39.163750 °	39.163750 °
				-121.609963 °	-121.609963 °
DWR ID	DWR_RD0010_01_s_2014_3				
Action/Comments					
Inspector Comments: FS_ID:27714					
EP_NO: N/A					
Repair Type:					
Crossing Status:					
UCIP Comments: Need to contact owner--unable to determine if crossing is authorized (no permit found).					
FIELD_STRUCT_DESC: Fiber optic line markers on levee slope unable to determine if line goes through levee. Multiple markers visible on waterward and landward side.					
FS Date: 4/29/2013

Markers visible on landward slope.

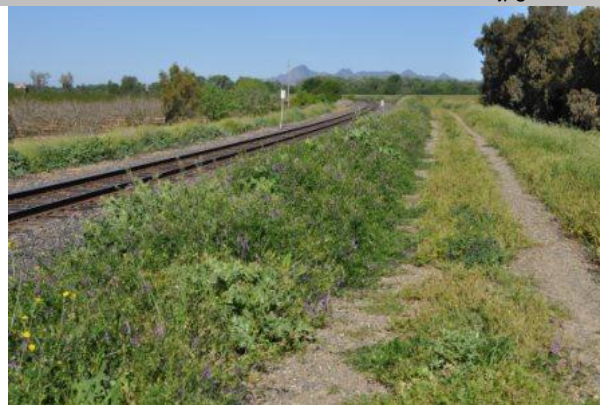
Photo 1 of 1 : mhoffman_s_20140421_434.jpg

LM Start	0.00	Rating **	M	Issue No.	5
LM End	0.72	Issue Type +	Ma	Location *	CR
Category	Earthen Levee			GPS Latitude/Longitude	
				Start	End
Item	Vegetation			39.163692 °	39.161210 °
				-121.609811 °	-121.597154 °
DWR ID	DWR_RD0010_01_s_2013_5				
Action/Comments					
Keep the crown roadway free of vegetation.

RD 10, Unit 1 - Vegetation on levee crown.

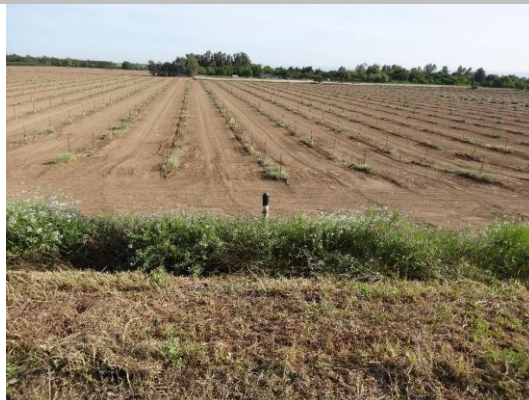
Photo 1 of 1 : UCIP_5465.jpg

LM Start	0.23	Rating **	M	Issue No.	4
LM End	0.23	Issue Type +	En	Location *	LS
Category	Supplemental			GPS Latitude/Longitude	
				Start	End
Item	DWR UCIP Field Study			39.163407 °	39.163407 °
				-121.605645 °	-121.605645 °
DWR ID	DWR_RD0010_01_s_2014_4				
Action/Comments					
Inspector Comments: FS_ID:27712					
EP_NO: N/A					
Repair Type:					
Crossing Status:					
UCIP Comments: Need to contact owner--unable to determine if crossing is authorized (no permit found) also need to determine if crossing goes through levee.					
FIELD_STRUCT_DESC: Fiber optic line markers on levee slope unable to determine if line goes through levee.					
FS Date: 4/29/2013

Marker visible on landward side.

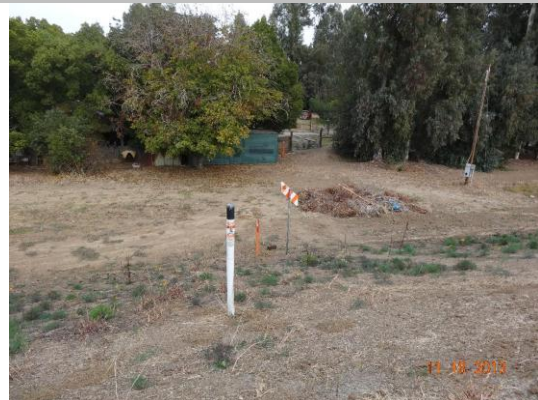
Photo 1 of 1 : UCIP_4221.jpg

LM Start	0.41	Rating **	M	Issue No.	11
LM End	0.41	Issue Type +	En	Location *	LS
Category	Supplemental			GPS Latitude/Longitude	
				Start	End
Item	DWR UCIP Field Study			39.162847 °	39.162847 °
				-121.602439 °	-121.602439 °
DWR ID	DWR_RD0010_01_s _ 2014_11				
Action/Comments					
Inspector Comments: FS_ID:24806					
EP_NO: 13015					
Repair Type:					
Crossing Status:					
UCIP Comments: New gravel indicates work was recently completed.					
Will need to contact owner to obtain information pertaining to work completed. Need to contact owner to determine if crossing is still active and to determine last inspection date. Will need copy of letter showing crossings passed inspection. This crossing is referenced in the USACE Periodic Inspection as item USACE_CESPK_HON1_2013_p_0075.					
FIELD_STRUCT_DESC: 4-inch pipe sleeved through an 8-inch pipe through the levee, 30.0 feet below the crown. Annular spaced grouted.

View of landward side--gas marker and conduit line marker.

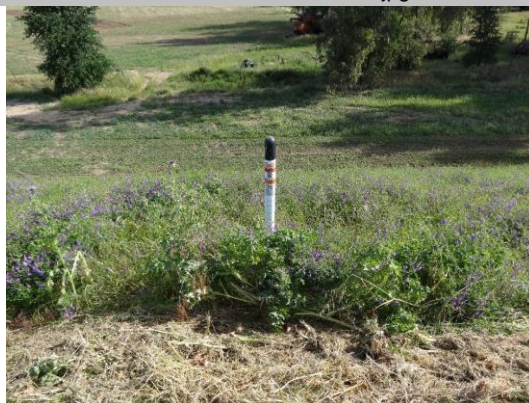
Photo 1 of 1 : UCIP_5463.jpg

LM Start	0.54	Rating **	M	Issue No.	12
LM End	0.54	Issue Type +	En	Location *	LS
Category	Supplemental			GPS Latitude/Longitude	
				Start	End
Item	DWR UCIP Field Study			39.162277 °	39.162277 °
				-121.600219 °	-121.600219 °
DWR ID	DWR_RD0010_01_s_2014_12				
Action/Comments					
Inspector Comments: FS_ID:27710					
EP_NO: N/A					
Repair Type:					
Crossing Status:					
UCIP Comments: Need to contact owner--unable to determine if crossing is authorized (no permit found) also need to determine if crossing goes through levee.					
FIELD_STRUCT_DESC: Fiber optic line markers on levee slope unable to determine if line goes through levee.					
FS Date: 4/29/2013

View of marker located on landward side.

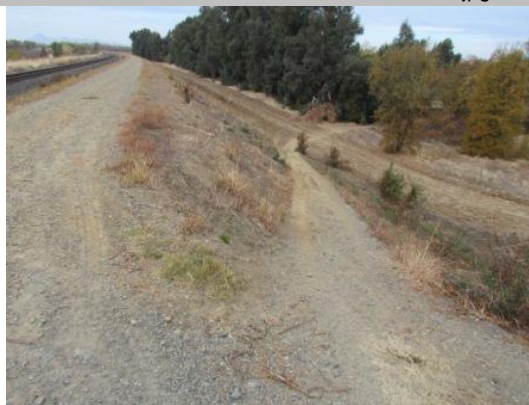
Photo 1 of 1 : mhoffman_s_20140421_437.jpg

LM Start	0.71	Rating **	M	Issue No.	48
LM End	0.71	Issue Type +	Ob	Location *	LS
Category	Earthen Levee			GPS Latitude/Longitude	
				Start	End
Item	Slope Stability			39.161198 °	39.161198 °
				-121.597102 °	-121.597102 °
DWR ID	DWR_RD0010_01_f_2013_48				
Action/Comments					
Repair the levee slope damaged by vehicle traffic and prevent access where possible.

This photo was taken from the crown looking down the landward slope at an ATV access road that has been formed over time to provide access to the waterward side. Fall 2013.

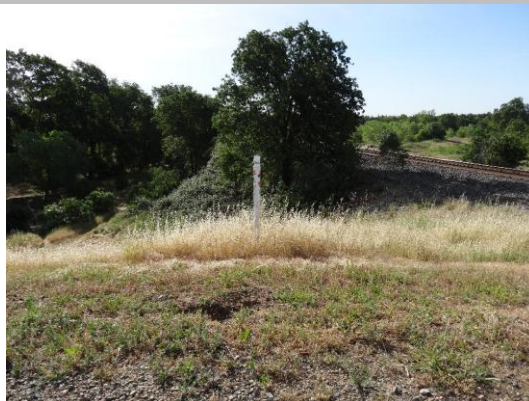
Photo 1 of 1 : UCIP_5472.jpg

LM Start	0.72	Rating **	M	Issue No.	13
LM End	0.72	Issue Type +	En	Location *	LS
Category	Supplemental			GPS Latitude/Longitude	
				Start	End
Item	DWR UCIP Field Study			39.161229 °	39.161229 °
				-121.597072 °	-121.597072 °
DWR ID	DWR_RD0010_01_s _ 2014_13				
Action/Comments					
Inspector Comments: FS_ID:27715					
EP_NO: N/A					
Repair Type:					
Crossing Status:					
UCIP Comments: Need to contact owner--unable to determine if crossing is authorized (no permit found) also need to determine if crossing goes through levee.					
FIELD_STRUCT_DESC: Fiber optic line markers on levee slope unable to determine if line goes through levee.					
FS Date: 4/29/2013

View of marker located on waterward side.

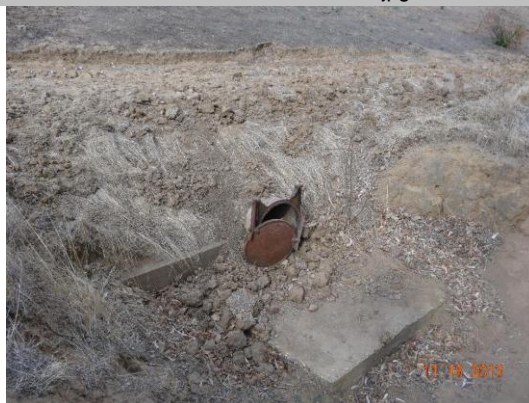
Photo 1 of 1 : UCIP_5483.jpg

Action/Comments					
Inspector Comments: FS_ID:27735					
EP_NO: N/A					
Repair Type:					
Crossing Status:					
UCIP Comments: Damaged flap gate on waterward side and damaged stem on screw gate on landward side. Need to contact owner to determine if crossing is still active. If crossing is still in use owner will need to address damage on flap gate and screw gate. If crossing is no longer in use owner will need to contact the CVFPB to comply with Title 23. This crossing is referenced in the USACE Periodic Inspection as item USACE_CESPK_HON1_2013_p_0053 and 0057.					
FIELD_STRUCT_DESC: 24-inch CM drainpipe through the levee, 31.0 feet below the crown. Two CM cutoff walls around pipe and concrete headwall at both ends. Flap gate on the waterward end. Slide gate on the landward end. Discharges into 6-foot concrete splash apron. (USACE-1953). This entry matches the Drainage or Irrigation Structure referenced in O&M manual (Station 46+60).

Damage flap gate located on waterward side.

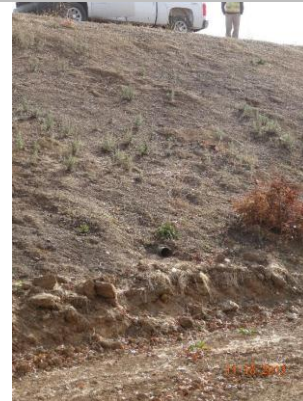
Photo 1 of 1 : UCIP_5487.jpg

LM Start	0.90	Rating **	M	Issue No.	15
LM End	0.90	Issue Type +	En	Location *	LS
Category	Supplemental			GPS Latitude/Longitude	
				Start	End
Item	DWR UCIP Field Study			39.163341 °	39.163341 °
				-121.595340 °	-121.595340 °
DWR ID	DWR_RD0010_01_s _ 2014_15				
Action/Comments					
Inspector Comments: FS_ID:27736					
EP_NO: N/A					
Repair Type:					
Crossing Status:					
UCIP Comments: Pipe is approximately 4-6 inches in diameter located near the toe of levee. Crossing is approximately 50 feet downstream of 24-inch pipe. Need to contact owner to determine status of this crossing and to verify the purpose of crossing. If crossing is no longer in use owner will need to contact the CVFPB to comply with Title 23.					
FIELD_STRUCT_DESC: Abandoned 6-inch steel drainpipe through the levee, 1.0 feet below the crown. Siphon breaker on the waterward shoulder. Pump located at landward toe. Revetment around discharge end of pipe, draining into ditch at waterward toe. Pipe is not buried on berms, gravel pad over pipe across levee crown for vehicular access.

Pipe through levee near waterward toe.

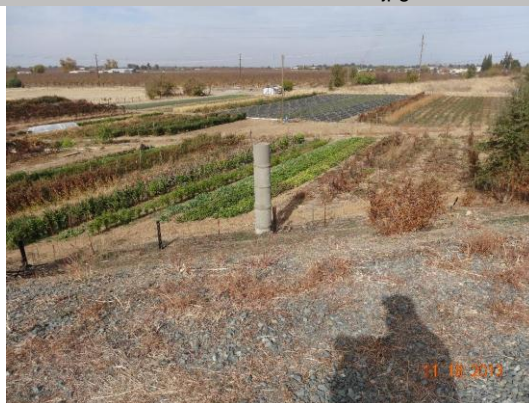
Photo 1 of 1 : UCIP_5474.jpg

LM Start	1.33	Rating **	M	Issue No.	16
LM End	1.33	Issue Type +	En	Location *	LS
Category	Supplemental			GPS Latitude/Longitude	
				Start	End
Item	DWR UCIP Field Study			39.168583 °	39.168583 °
				-121.590929 °	-121.590929 °
DWR ID	DWR_RD0010_01_s_2014_16				
Action/Comments					
Inspector Comments: FS_ID:27725					
EP_NO: N/A					
Repair Type:					
Crossing Status:					
UCIP Comments: Crossing appears not to be in use--need to contact owner. Need to coordinate with owner to determine status of crossing. If crossing is no longer in use owner will need to contact the CVFPB to comply with Title 23. This crossing is referenced in the USACE Periodic Inspection as item USACE_CESPK_HON1_2013_p_0012.					
FIELD_STRUCT_DESC: 10-inch steel pipe through the levee, 7.3 feet below the crown. Siphon breaker in CM riser on the waterward slope. Pump on the waterward berm-pump not present. Switch house on the waterward slope-no switch house present. 24-inch concrete standpipe at the landward toe. (USACE-1955). This entry matches the Drainage or Irrigation Structure referenced in O&M manual (Station 14+82).

View of landward side.

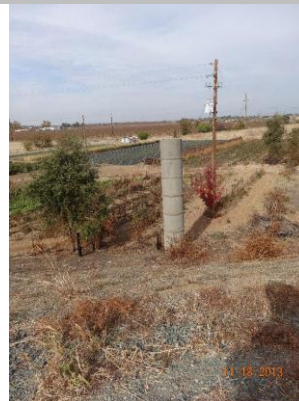
Photo 1 of 1 : UCIP_4231.jpg

LM Start	1.35	Rating **	M	Issue No.	17
LM End	1.35	Issue Type +	En	Location *	LS
Category	Supplemental			GPS Latitude/Longitude	
				Start	End
Item	DWR UCIP Field Study			39.168670 °	39.168670 °
				-121.590731 °	-121.590731 °
DWR ID	DWR_RD0010_01_s_2014_17				
Action/Comments					
Inspector Comments: FS_ID:24810 EP_NO: N/A Repair Type: Crossing Status: UCIP Comments: Pipe has been capped on waterward side--see photos. Need to coordinate with DWR Inspector to determine whether crossing is compliant with Title 23. This crossing is referenced in the USACE Periodic Inspection as item USACE_CESPK_HON1_2013_p_0016. FIELD_STRUCT_DESC: 10-inch steel pipe through the levee, 6.8 feet below the crown. Steel cutoff plate around pipe at center of levee. Siphon breaker in CM riser on the waterward slope. Pump on concrete base on the waterward berm-not present. 36-inch concrete standpipe at the landward toe. Metal shed and service pole on the waterward slope-not present. (USACE-1955). This entry matches the Drainage or Irrigation Structure referenced in O&M manual (Station 14+16). FS Date: 4/29/2013

View of landward side.

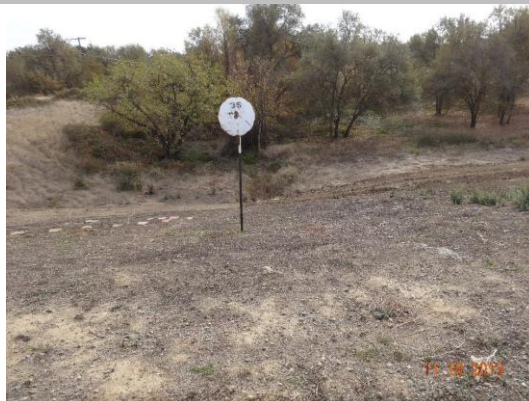
Photo 1 of 1 : UCIP_4235.jpg

LM Start	1.42	Rating **	M	Issue No.	19
LM End	1.42	Issue Type +	En	Location *	LS
Category	Supplemental			GPS Latitude/Longitude	
				Start	End
Item	DWR UCIP Field Study			39.169080 °	39.169080 °
				-121.589478 °	-121.589478 °
DWR ID	DWR_RD0010_01_s_2014_19				
Action/Comments					
Inspector Comments: FS_ID:24812					
EP_NO: N/A					
Repair Type:					
Crossing Status:					
UCIP Comments: Holes present on pipe wall. Need to contact owner to notify of issue with pipe. Also need to contact DWR Inspector and CVFPB to determine how to address issue. This crossing is referenced in the USACE Periodic Inspection as item					
USACE_CESPK_HON1_2013_p_0140. Pipe should be 30-inch instead of 36-inch mentioned Periodic Inspection.					
FIELD_STRUCT_DESC: 30-inch CM pipe through the levee, approximately 30 feet below the crown. Two CM cutoff walls around the pipe on both sides. Saddle and splash apron at the discharge end of the pipe. Concrete saddle and apron on waterward side. (USACE-1955). This entry matches the Drainage or Irrigation Structure referenced in O&M manual (Station 10+38).

View of waterward side--marker present on waterward shoulder.

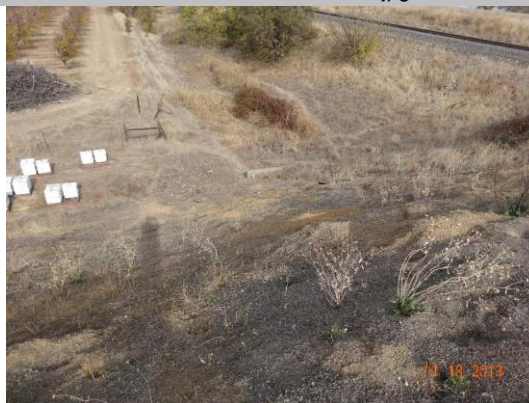
Photo 1 of 1 : UCIP_5528.jpg

Action/Comments					
Inspector Comments: FS_ID:27791					
EP_NO: N/A					
Repair Type:					
Crossing Status:					
UCIP Comments: Vegetation has been cleared from slope. This crossing is referenced in the USACE Periodic Inspection as item USACE_CESPK_HON1_2013_p_0158.					
FIELD_STRUCT_DESC: 24-inch CM drainpipe through the levee, 30.0 feet below the crown. Flap gate on the waterward end. Slide gate on the landward end. Concrete saddle and apron on waterward side. (USACE-1955). This entry matches the Drainage or Irrigation Structure referenced in O&M manual (Station 1+00).					
FS Date: 4/29/2013

View of landward side after vegetation clearing.

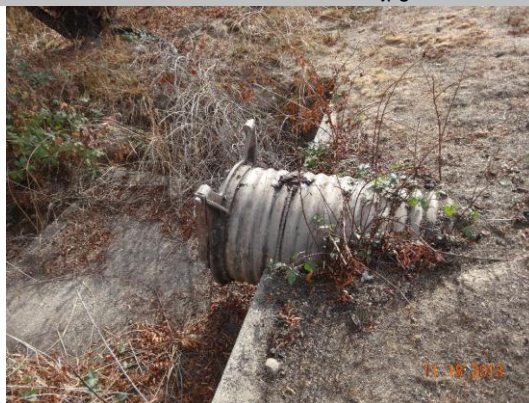
Photo 1 of 1 : UCIP_5492.jpg

LM Start	2.15	Rating **	M	Issue No.	21
LM End	2.15	Issue Type +	En	Location *	LS
Category	Supplemental			GPS Latitude/Longitude	
				Start	End
Item	DWR UCIP Field Study			39.176936 °	39.176936 °
				-121.584848 °	-121.584848 °
DWR ID	DWR_RD0010_01_s_2014_21				
Action/Comments					
Inspector Comments: FS_ID:27745					
EP_NO: N/A					
Repair Type:					
Crossing Status:					
UCIP Comments: Unable to determine if crossing is still present on landward side--need to confirm. Need to contact owner to determine status of crossing. This crossing is referenced in the USACE Periodic Inspection as item USACE_CESPK_HON1_2013_p_0185.					
FIELD_STRUCT_DESC: 24-inch pipe through the levee, 30.0 feet below the crown. Flap gate on waterward end. Concrete headwall at both toes.					
FS Date: 4/29/2013

View of pipe, headwall, and flap gate located on waterward side.

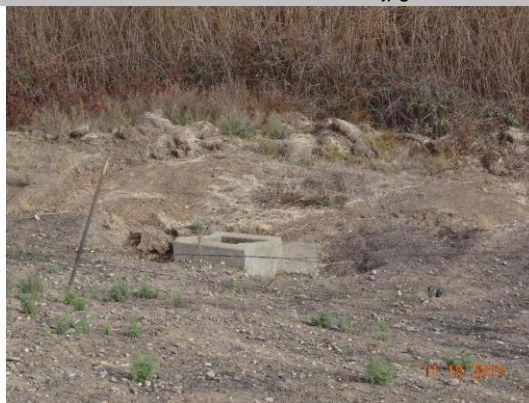
Photo 1 of 1 : UCIP_4244.jpg

LM Start	2.79	Rating **	M	Issue No.	22
LM End	2.79	Issue Type +	En	Location *	LS
Category	Supplemental			GPS Latitude/Longitude	
				Start	End
Item	DWR UCIP Field Study			39.186134 °	39.186134 °
				-121.583719 °	-121.583719 °
DWR ID	DWR_RD0010_01_s_2014_22				
Action/Comments					
Inspector Comments: FS_ID:24815					
EP_NO: 14020					
Repair Type:					
Crossing Status:					
UCIP Comments: Unable to determine status of crossing--sink hole was observed as part of the USACE Periodic Inspection Report dated May 2013. Need to coordinate with owner to determine status of crossing. If crossing is no longer in use owner will need to contact the CVFPB to comply with Title 23. Need to confirm with Finney to determine if pump and controls belong to pipe crossing located on landward side. This crossing is referenced in the USACE Periodic Inspection as item USACE_CESPK_HON1_2013_p_0192.					
FIELD_STRUCT_DESC: 10-inch steel drainpipe sleeved through a 16-inch steel pipe, 5.0 feet below the crown. Annular gap grouted.

Concrete box located at waterward toe--fence limits access to appurtenance.

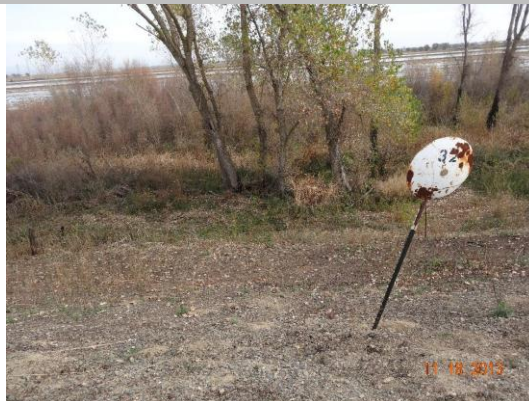
Photo 1 of 1 : UCIP_4247.jpg

UCIP Comments: Indicator marker visible on WS; Dense vegetation on waterward toe and landward side access limits the inspector's visibility to identify signs of pipe failure (leaks) along the slope. Recommend removing vegetation along pipe alignment to conduct proper inspection of structure and appurtenances. Access to landward side will need to be coordinated with railroad. Need to coordinate with owner to determine status of crossing. If crossing is no longer in use owner will need to contact the CVFPB to comply with Title 23. This crossing is referenced in the USACE Periodic Inspection as item

View of waterward slope.

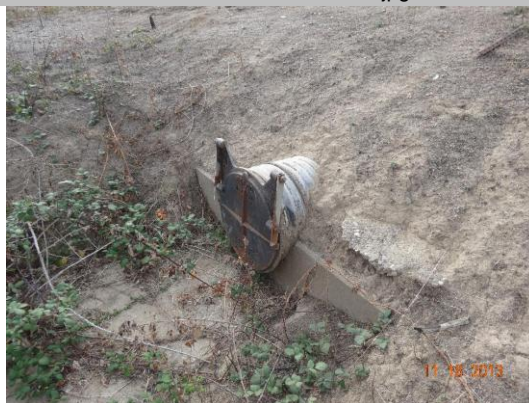
Photo 1 of 1 : UCIP_5499.jpg

Action/Comments					
Inspector Comments: FS_ID:27747					
EP_NO: N/A					
Repair Type:					
Crossing Status:					
UCIP Comments: sign marker on WS 30; Unable to confirm landward side. This crossing is referenced in the USACE Periodic Inspection as item USACE_CESPK_HON1_2013_p_0232.					
FIELD_STRUCT_DESC: 24-inch CM drainpipe through the levee, 18.0 feet below the crown. CM cutoff wall around pipe at center of levee. Flap gate and splash apron (6x6 foot) on the waterward end. (USACE-1953). This entry matches the Drainage or Irrigation Structure referenced in O&M manual (Station 339+55.10).					
FS Date: 4/29/2013

View of pipe, flap gate, and headwall located on waterward toe.

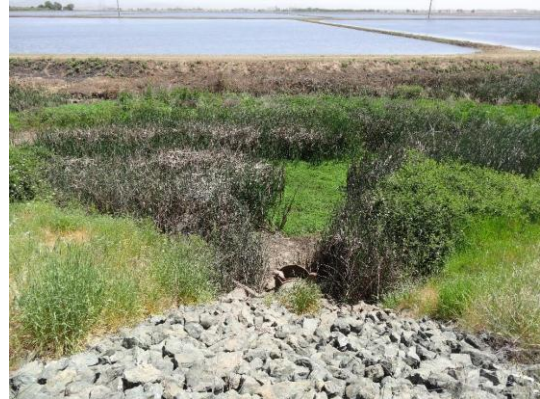
Photo 1 of 1 : UCIP_4316.jpg

LM Start	4.92	Rating **	M	Issue No.	25
LM End	4.92	Issue Type +	En	Location *	LS
Category	Supplemental			GPS Latitude/Longitude	
				Start	End
Item	DWR UCIP Field Study			39.216591 °	39.216591 °
				-121.579919 °	-121.579919 °
DWR ID	DWR_RD0010_01_s _ 2014_25				
Action/Comments					
Inspector Comments: FS_ID:24872					
EP_NO: N/A					
Repair Type:					
Crossing Status:					
UCIP Comments: limited access; steep slopes, and dense vegetation;					
New riprap has been placed along pipe alignment need to contact					
owner to determine work authorization. Also need to find out if the					
design for riprap was due to slope failure at this location. This crossing					
is referenced in the USACE Periodic Inspection as item					
USACE_CESPK_HON1_2013_p_0246.					
FIELD_STRUCT_DESC: 36-inch CM pipe through the levee, 20.0 feet					
below the crown. Two CM cutoff walls around pipe at both shoulders.					
Flap gate on the waterward end. Concrete headwall at waterward toe.

View of waterward side during April.

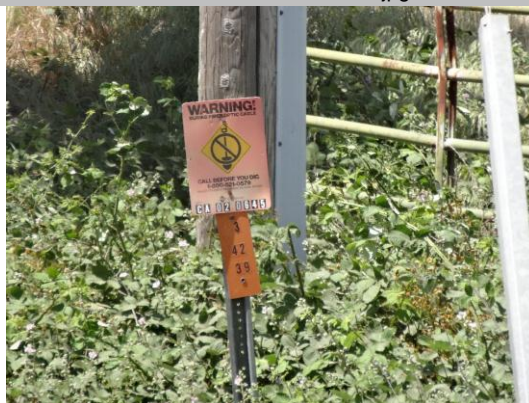
Photo 1 of 1 : UCIP_5430.jpg

LM Start	6.16	Rating **	M	Issue No.	26
LM End	6.16	Issue Type +	En	Location *	LS
Category	Supplemental			GPS Latitude/Longitude	
				Start	End
Item	DWR UCIP Field Study			39.234389 °	39.234389 °
				-121.577620 °	-121.577620 °
DWR ID	DWR_RD0010_01_s_2014_26				
Action/Comments					
Inspector Comments: FS_ID:27531					
EP_NO: 6127					
Repair Type:					
Crossing Status:					
UCIP Comments: Recommend removing vegetation along pipe alignment to conduct proper inspection of structure and appurtances.					
FIELD_STRUCT_DESC: Two 1-inch aluminum conduits through the levee, 3.0 feet below the crown. Cutoff wall around conduits at center of levee. (Permit No. 6217-1968)					
FS Date: 4/29/2013

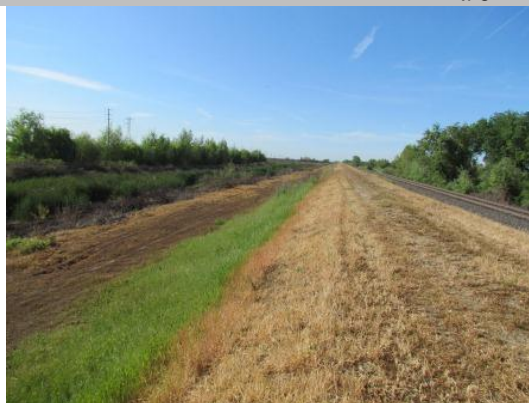
Photo 1 of 1 : mhoffman_s_20140428_488.jpg

LM Start	6.18	Rating **	A/W	Issue No.	43
LM End	6.51	Issue Type +	Ma	Location *	WS
Category	Earthen Levee			GPS Latitude/Longitude	
				Start	End
Item	Vegetation			39.234724 °	39.239359 °
				-121.577591 °	-121.576950 °
DWR ID	DWR_RD0010_01_f_2013_43				
Action/Comments					
Control annual grass and weeds on the levee slopes and easements.

This photo was taken from the levee crown facing south looking down the waterward levee slope at vegetation requiring maintenance. Spring 2014.

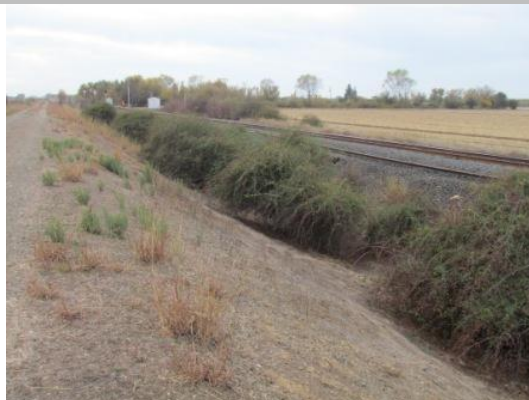
Photo 1 of 1 : mhoffman_s_20140421_436.jpg

This photo was taken from the levee crown facing south looking down the landward slope at wild roses growing near the toe. Fall 2013.

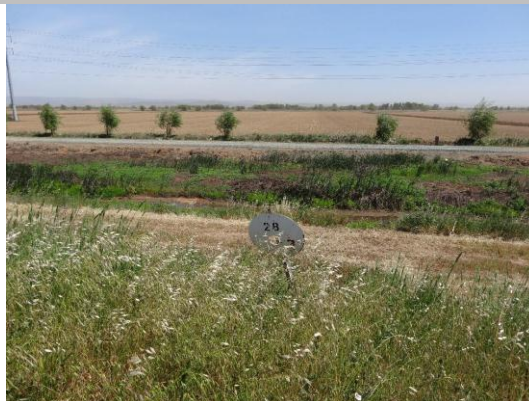
Photo 1 of 1 : UCIP_4126.jpg

UCIP Comments: Dense vegetation limits the inspector's visibility to identify signs of pipe failure (leaks) along the slope. Recommend removing vegetation along pipe alignment to conduct proper inspection of structure and appurtenances. This crossing is referenced in the USACE Periodic Inspection as item USACE_CESPK_HON1_2013_p_0290.

Marker visible on waterward shoulder.

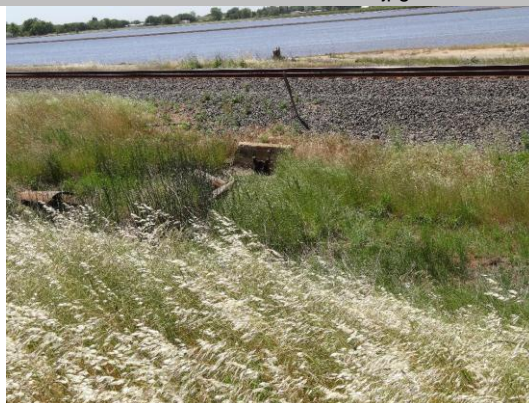
Photo 1 of 1 : UCIP_5434.jpg

LM Start	6.67	Rating **	M	Issue No.	28
LM End	6.67	Issue Type +	En	Location *	LS
Category	Supplemental			GPS Latitude/Longitude	
				Start	End
Item	DWR UCIP Field Study			39.241726 °	39.241726 °
				-121.576488 °	-121.576488 °
DWR ID	DWR_RD0010_01_s _ 2014_28				
Action/Comments					
Inspector Comments: FS_ID:27532					
EP_NO: N/A					
Repair Type:					
Crossing Status:					
UCIP Comments: Need to clear sediment near gate. Need to coordinate with owner to determine status of crossing. If crossing is no longer in use owner will need to contact the CVFPB to comply with Title 23. This crossing is referenced in the USACE Periodic Inspection as item USACE_CESPK_HON1_2013_p_0291-294.					
FIELD_STRUCT_DESC: 16-inch-steel pipe through the levee, 10.3 feet below the crown. Cutoff wall around pipe at center of levee. Slide gate on the waterward end. Pipe exposed across irrigation canal on landward side. (USACE-1953). This entry matches the Drainage or Irrigation Structure referenced in O&M manual (Station 473+58).

View of concrete headwall located at the toe of the railroad located on landward side.

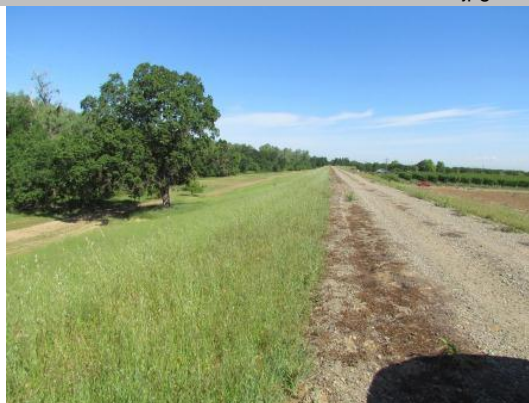
Photo 1 of 1 : mhoffman_s_20140428_489.jpg

This photo was taken from the levee crown facing west looking down the waterward levee slope at vegetation requiring maintenance. Spring 2014.

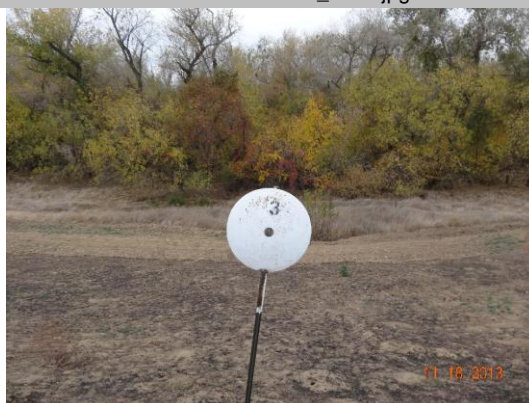
Photo 1 of 1 : UCIP_5442.jpg

Inspector Comments: FS_ID:27533
 EP_NO: N/A
 Repair Type:
 Crossing Status:
 UCIP Comments: Recommend removing vegetation and debris along pipe alignment (debris blocking gate on waterward side and vegetation blocking access to screw gate on landward side). Need to coordinate with owner to determine status of crossing. If crossing is no longer in use owner will need to contact the CVFPB to comply with Title 23. This crossing is referenced in the USACE Periodic Inspection as item USACE_CESPK_HON2_2013_p_0027.
 FIELD_STRUCT_DESC: 24-inch CM pipe through the levee, 25.6 feet below the crown. Two CM cutoff walls around pipe at both shoulders. Flap gate on the waterward end. Concrete headwall, saddle and apron on the waterward end. (USACE-1953). This entry matches the Drainage or Irrigation Structure referenced in O&M manual (Station 106+00).
 FS Date: 4/30/2013

View of waterward side.

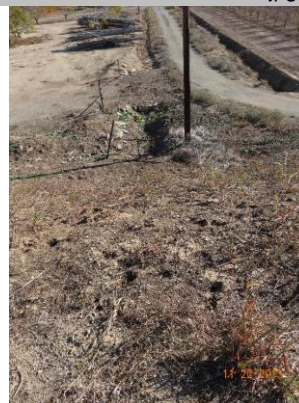
Photo 1 of 1 : UCIP_4254.jpg

LM Start	1.20	Rating **	M	Issue No.	2
LM End	1.20	Issue Type +	En	Location *	WS
Category	Supplemental			GPS Latitude/Longitude	
				Start	End
Item	DWR UCIP Field Study			39.180875 °	39.180875 °
				-121.610052 °	-121.610052 °
DWR ID	DWR_RD0010_02_s_2014_2				
Action/Comments					
Inspector Comments: FS_ID:24821					
EP_NO: N/A					
Repair Type:					
Crossing Status:					
UCIP Comments: Screw gate on landward side is blocked by sediment. Recommend removing sediment in front of gate. This crossing is referenced in the USACE Periodic Inspection as item					
USACE_CESPK_HON2_2013_p_0082.					
FIELD_STRUCT_DESC: 24-inch CM pipe through the levee, 26.0 feet below the crown. Two CM cutoff walls around pipe at both shoulders.					
Flap gate on the waterward end. Slide gate on landward end. Concrete headwall, saddle and apron on the waterward end. (USACE-1953). This entry matches the Drainage or Irrigation Structure referenced in O&M manual (Station 149+88).

View of landward slope.

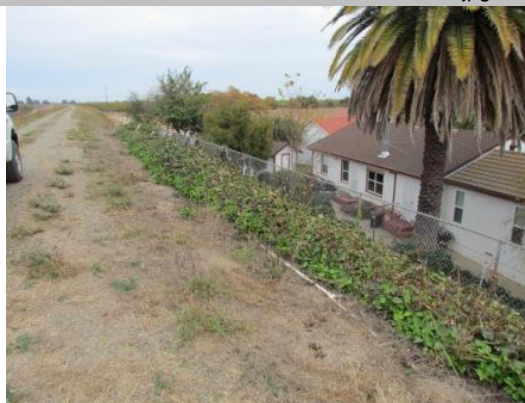
Photo 1 of 1 : mhoffman_s_20140421_457.jpg

LM Start	1.35	Rating **	M	Issue No.	9
LM End	1.35	Issue Type +	En	Location *	LS
Category	Earthen Levee			GPS Latitude/Longitude	
				Start	End
Item	Vegetation			39.182957 °	39.182957 °
				-121.609800 °	-121.609800 °
DWR ID	DWR_RD0010_02_s_2012_9				
Action/Comments					
Landscaping

This photo was taken from the crown looking down the landward slope at landscaping and a fence. Fall 2013.

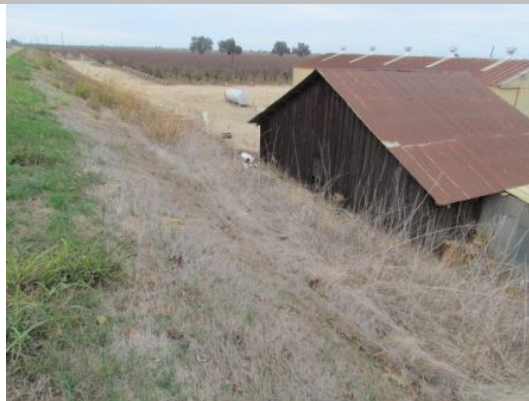
Photo 1 of 1 : mhoffman_s_20140421_459.jpg

This photo was taken from the crown facing north looking down the landward levee slope at an outbuilding near the levee toe. Fall 2013.

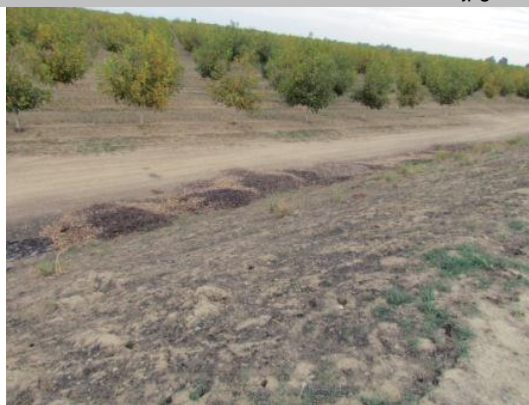
Photo 1 of 1 : mhoffman_s_20140421_460.jpg

LM Start	3.02	Rating **	M	Issue No.	66
LM End	3.02	Issue Type +	En	Location *	LS
Category	Earthen Levee			GPS Latitude/Longitude	
				Start	End
Item	Encroachments			39.206963 °	39.206963 °
				-121.609787 °	-121.609787 °
DWR ID	DWR_RD0010_02_f_2013_66				
Action/Comments					
Debris					
Inspector Comments: Walnut hulls at landward levee toe.

This photo was taken from the crown facing south looking down the landward slope at a pile of walnut hulls at the levee toe. Fall 2013.

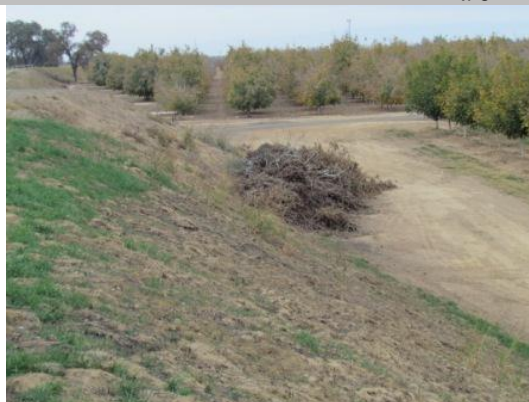
Photo 1 of 1 : mhoffman_s_20140421_461.jpg

This photo was taken from the levee crown facing north looking down the landward levee slope at a pruning pile near the levee toe. Fall 2013.

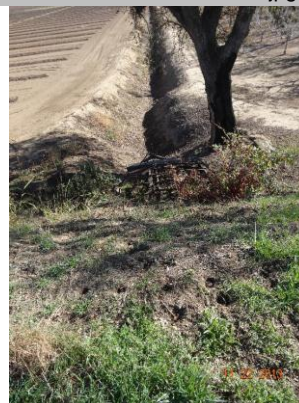
Photo 1 of 1 : UCIP_4256.jpg

View of landward side--barrier used to discourage damage to crossing
near toe.

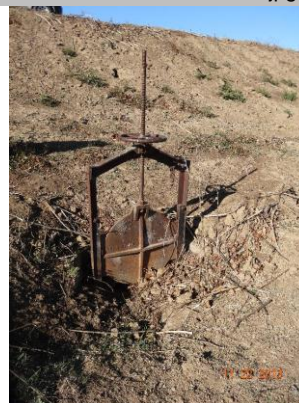
Photo 1 of 1 : UCIP_4265.jpg

View of screw gate located on landward toe blocked by sediment.

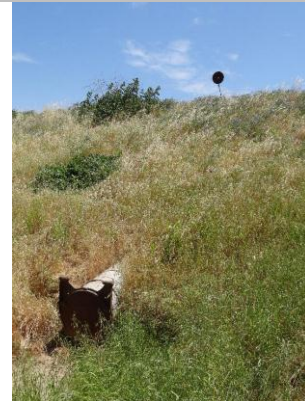
Photo 1 of 1 : UCIP_4207.jpg

View of waterward side--dense vegetation on slope.

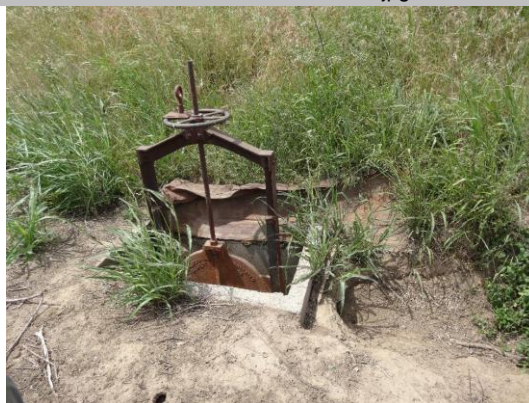
Photo 1 of 1 : UCIP_5529.jpg

Action/Comments
 Inspector Comments: FS_ID:27793
 EP_NO: N/A
 Repair Type:
 Crossing Status:
 UCIP Comments: Need to contact owner to remove debris inside concrete distribution box and on slope. This crossing is referenced in the USACE Periodic Inspection as item USACE_CESPK_HON2_2013_p_0244.
 FIELD_STRUCT_DESC: 30-inch CM drainpipe through the levee, 17.3 feet below the crown. Two CM cutoff walls around pipe at both shoulders. Flap gate on the waterward end. Slide gate on the landward end. Concrete headwalls at both ends. (USACE-1953). This entry matches the Drainage or Irrigation Structure referenced in O&M manual (Station 413+81).
 FS Date: 4/30/2013

View of screw gate located on landward side.

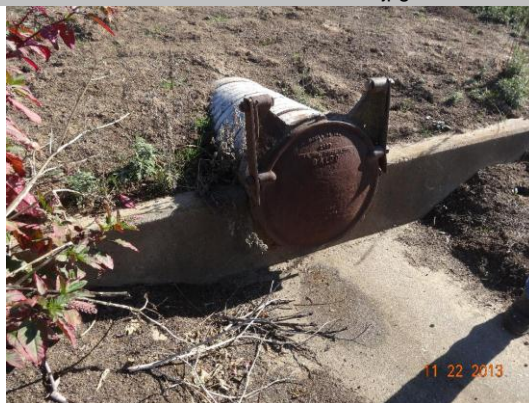
Photo 1 of 1 : UCIP_4282.jpg

View of flap gate visible on waterward side.

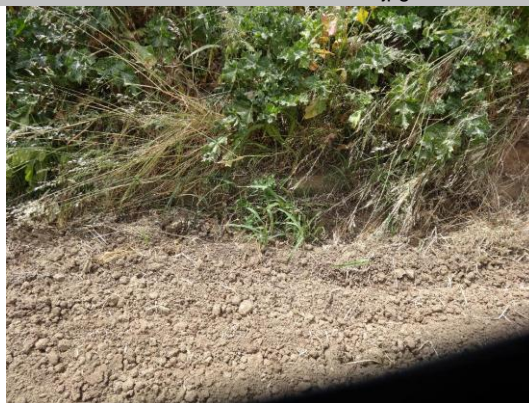
Photo 1 of 1 : UCIP_4210.jpg

View of concrete headwall visible through dense vegetation.

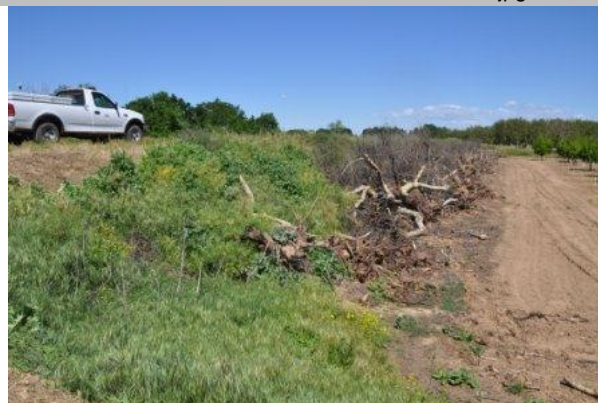
Photo 1 of 1 : mhoffman_s_20140421_458.jpg

RD 10, Unit 2 - pruning piles on L/S levee slope.

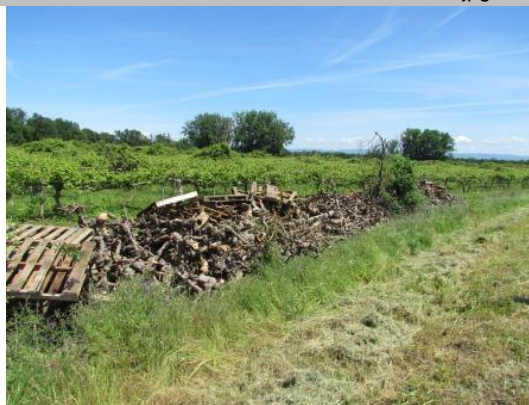
Photo 1 of 1 : mhoffman_s_20140428_490.jpg

This photo was taken from the levee crown facing east looking down the waterward slope at a pruning pile at the levee toe. Spring 2014.

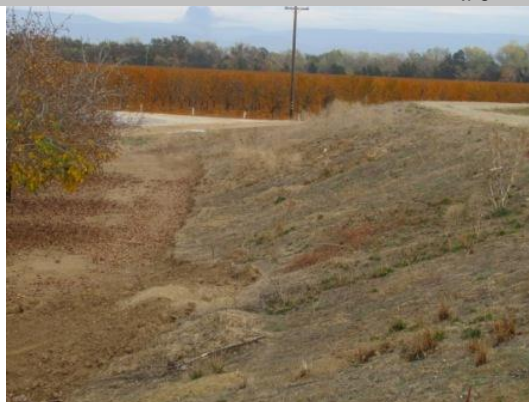
Photo 1 of 1 : mhoffman_s_20140421_480.jpg

This photo was taken from the levee crown facing north looking down the waterward slope at agricultural tilling causing a cut at the levee toe. Fall 2013.
